AKTUELLE PAPIER-RUNDSCHAU

2012 | Nr. 04
www.a-p-r.de

Vacuum Pumps Service + Retrofit

MASSIVE ENERGY SAVINGS BY VACUUM PUMP RETROFITTING

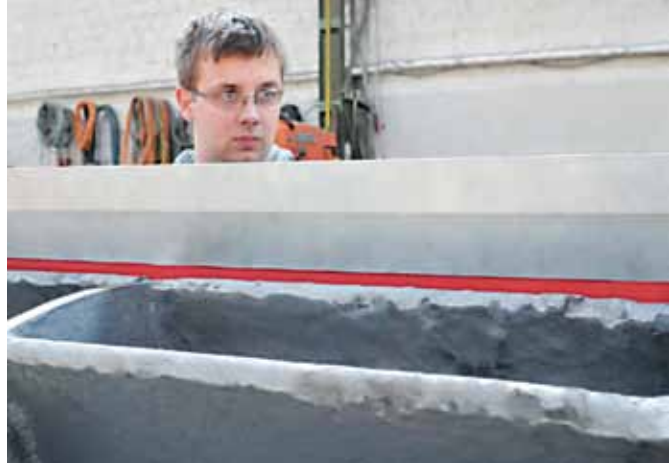
Worn out vacuum pump impeller Siemens Elmo after sand blasting. The material deterioration of the impeller is marked in red.

Different types of wear and tear can occur with liquid seal vacuum pumps. Especially in the recycling paper sector, abrasion from solid particles has to be expected. It causes strong erosions on the housing and head pieces. Mechanical damages also result if the partial air pressure in the air/steam mixture falls short of 16 mbar because of cavitation. This can happen with high vacuum or high sealing water temperatures or a combination of both. The reason for this is the deculator in most cases. Corrosionlike damage can also be caused by the sealing water’s so called conductivity, meaning the capacity to conduct electricity. This physical value should be inspected on site at regular intervals. Vacuum pump Specialist H.F. Laub recommends inspecting the pump with an

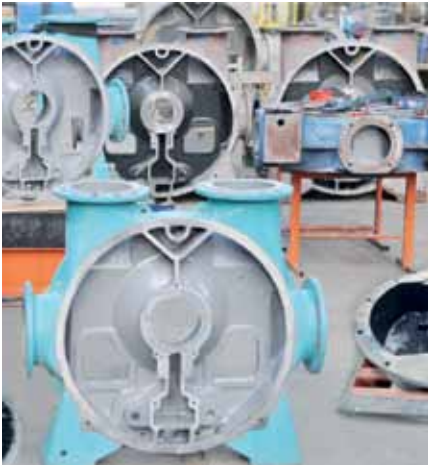
Side brackets coated with the composites that are adjusted to the relevant use conditions

Enlarged gaps are regenerated, i.e. returned to their original size by means of highly wear-resistant materials. Sections with deposits are coated with special composite materials after the deposits are removed and these materials will prevent new deposits or at least reduce them in the future.

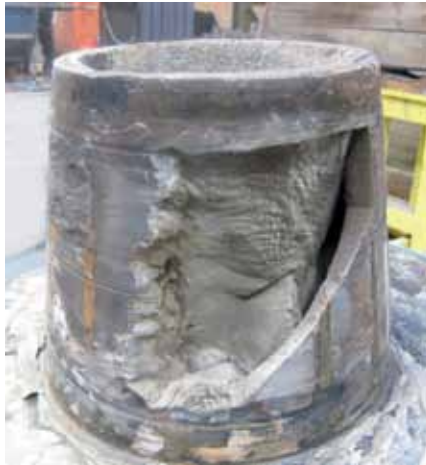
Clogged Nash cone, the on-site analysis showed an 85% loss of performance

The analysis of the performance test had shown that the loss of performance on liquid seal vacuum pumps has doubled in the past 20 years from one percent annually to a rounded 2%. Playing an important part in this development are the substantially increased deposits, specifically in the discharge area of the cones or the slots in the control disks. According to the company, soiling caused by the increasing use of recycling paper has become more frequent and in addition, pumps are burdened by the proliferating use of chemicals in the recycling paper processing.

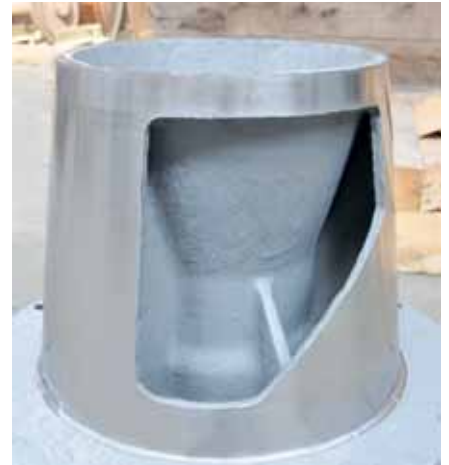
Cleaned Nash cone which was additionally coated with composites protecting against new deposits
